Grant Agreement No.	606645
Acronym	RPB HealTec
Title	ROAD PAVEMENTS & BRIDGE DECK HEALTH MONITORING / EARLY WARNING USING ADVANCED INSPECTION TECHNOLOGIES
Call	FP7-SME-2013
Funding Scheme	BSG-SME

Deliverable D9.2

Review of highway standards and manuals

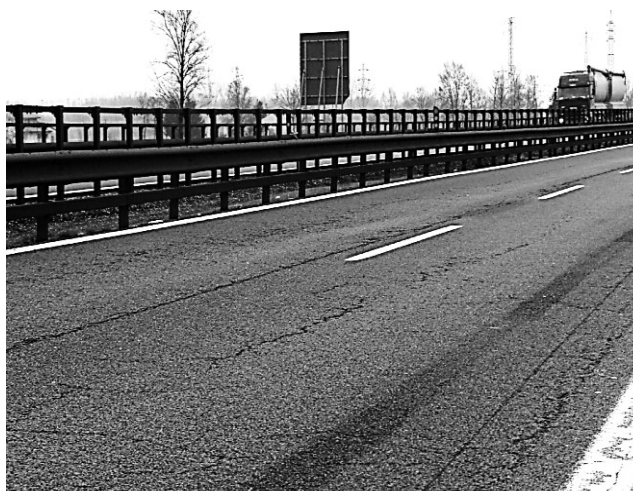
b. Drainage sound-absorbing pavements in the Brenner-Motorway

Most of the pavements along the Brenner Motorway are drainage sound-absorbing pavements, which are considered to be optimal in terms of safety as they reduce aquaplaning, spray and mirror effects. This full depth asphalt pavement type with surface drainage system is characterised by the absence of granular sub-base layer and water impenetrable binder course (Figure 2.6.d). In pavements of this type moisture contents do not build up in the subgrades.

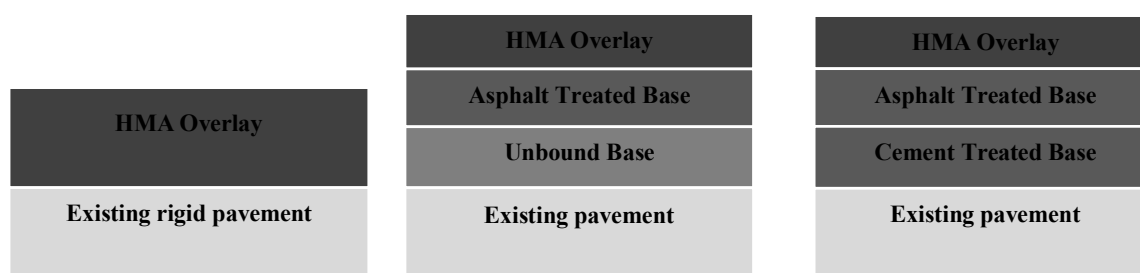
Figure 2.7 Common types of HMA surfaced composite pavements

Figure 2.7 shows some typical structures of composite pavements, also known as HMA or AC overlays, commonly used as a rehabilitation option. It can consist only of the HMA course, or also include base layers: unbound, asphalt treated, cement treated. HMA overlays are also classified depending on the type of initial pavement: asphalt pavement, jointed plain concrete pavement (HMA/JPCP), continuously reinforced concrete pavement (HMA/CRCP), etc. However, because of reflection cracking caused by poor joints this type of construction requires inspection and treatment of the initial surface for cost-effective rehabilitation.

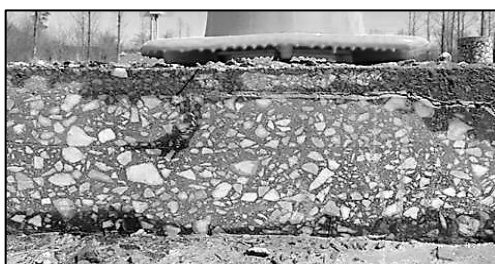
a. Debonding in HMA layers [23]

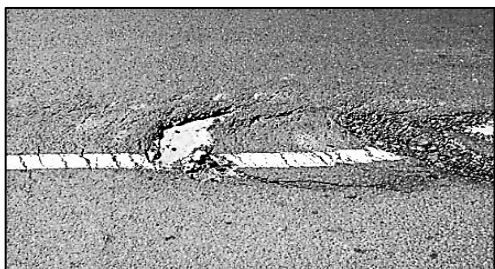
c. Severe slippage caused by debonding [38]

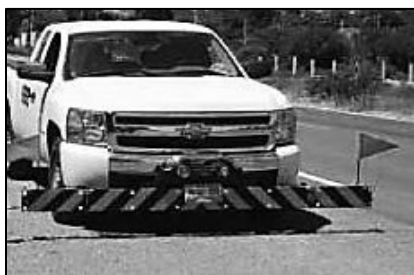
a. Acuity® laser profiler [27]

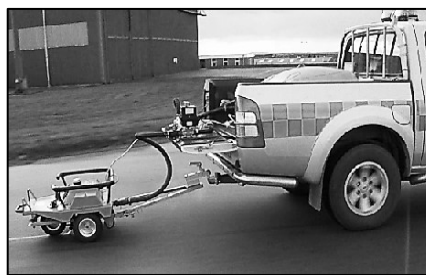
b. GripTester skid resistance measurement equipment [28]

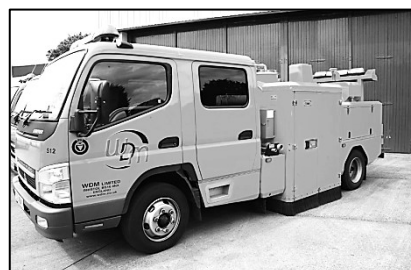
Figure 3.3 WDM® SCRIM system [30]

Skid resistance is defined by the surface micro and macro textures and its monitoring is of a particular concern due to the increased risk of accidents during wet weather conditions. A skid resistance survey is generally performed with either a locked-wheel skid trailer towed behind a vehicle (with a water tank), or a trunk mounted SCRIM (Sideway Force Coefficient Investigation Machine) system operating at speeds of up to 80 km/h. It measures the resultant resistance force to calculate surface frictional properties during simulated wet conditions (Figure 3.2.b). The results are represented as skid scores assigned along the inspected pavement segment (e.g., range 10-65, where greater values indicate higher skid resistance and high friction surface). The Brenner Motorway uses a SCRIM system (Figure 3.3), or equivalent, with reference to the CNR BU n. 147/92 "Standards for the measurement of surface features of pavements - Test method for measuring the grip coefficient with the SCRIM device" and/or similar European standards (CEN 15901-6 and 15901-8).

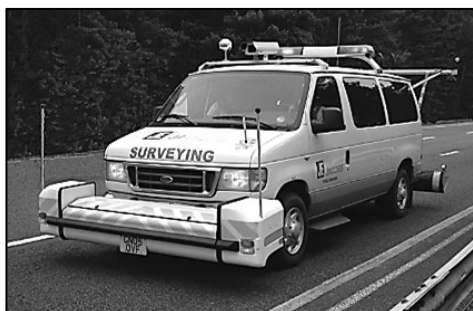
a. TRACS traffic speed pavement survey system [2]

Another example of functional pavement condition measurement equipment is the TRACS (Traffic Speed Condition Surveys) system commonly used in the UK for trunk road network functional condition inspection. The pavement surface condition (texture profile, crack maps, transverse and longitudinal profiles) is measured with sensors and four view HDV cameras at speeds of up to 100 km/h. Defect detection is based on image processing and GPS location referencing (Figure 3.4.a). The Brenner Motorway uses a similar integrated system called ARAN (Automatic Road Analyser) that combines a laser profilometer, HDV, and GPS for data acquisition, and operates at traffic speeds (60 - 100 km/h) thus causing minimum traffic disruption. Tire-pavement noise is directly related to the surface macrotexture and is generally measured during phonometric surveys with fixed microphone located near the vehicle tire. In addition, phonometric surveys are also used for estimation of the acoustic pollution and potential draining capacity of pavements.

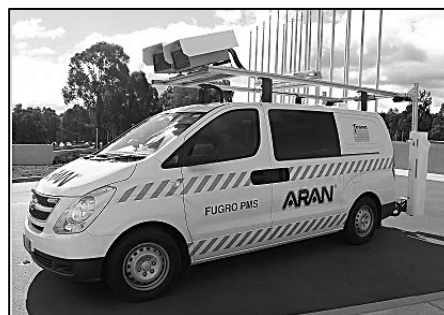
b. ARAN system [23]

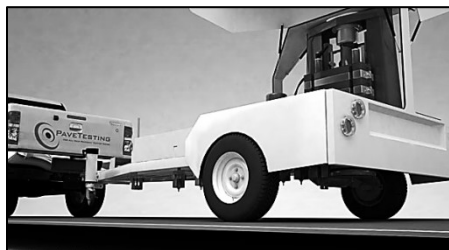
a. PaveTesting® FWD equipment [29]

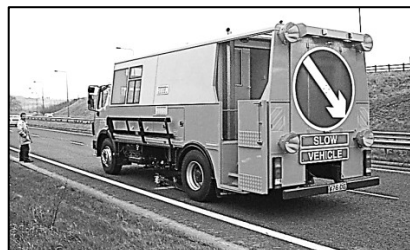
b. WDM® Deflectograph [30]

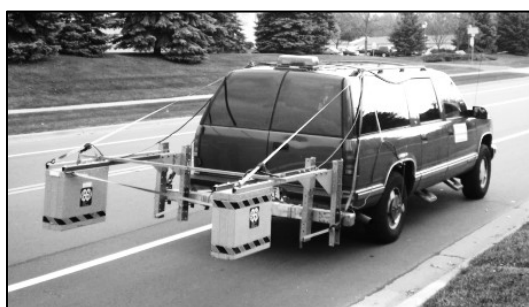
a. Air-coupled GPR system [2]

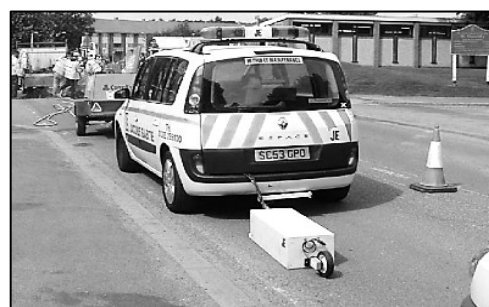
b. Ground-coupled GPR system [24]

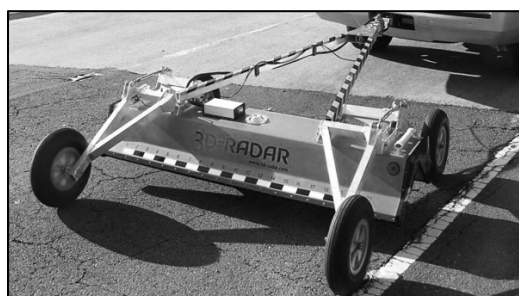
c. 3-D Radar® 3D GPR [21]

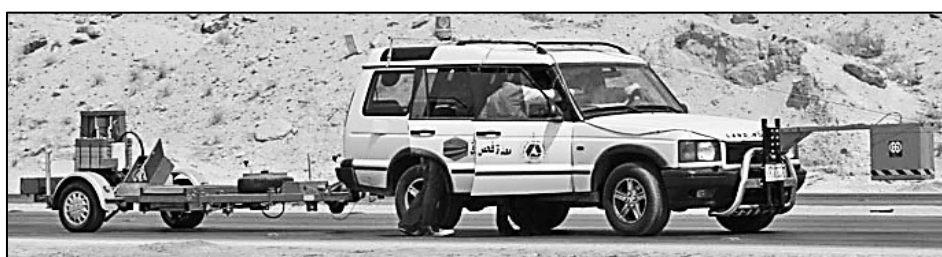
Figure 3.7 GSSI® Integrated GRP and FWD system [25]

deeper into the pavement structure. Ground-coupled GPR is used for localisation of buried objects and estimation of deep water damage. GPR is mainly used on flexible pavements due to signal interference with the reinforcing steel joints in rigid pavements. New generation 3D GPR systems provide full lane width coverage with multi-channel antenna arrays, which allows reconstruction of 3D images of the subsurface objects (Figure 3.6.c-d). Portable GPR inspection systems are used for inspection of specific locations that require accurate subsurface measurement, e.g. bridge decks, concrete structures, utility mapping. Some of the inspection systems combine several NDT techniques. For instance, Figure 3.7 demonstrates an integrated pavement survey system with GPR providing information on pavement layer thicknesses for FWD measurements to achieve the correct interpretation of the corresponding layer stiffnesses.

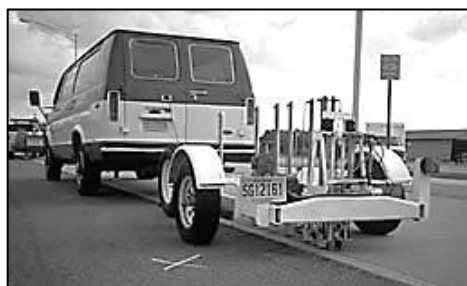
a. Seismic Pavement Analyser [26]

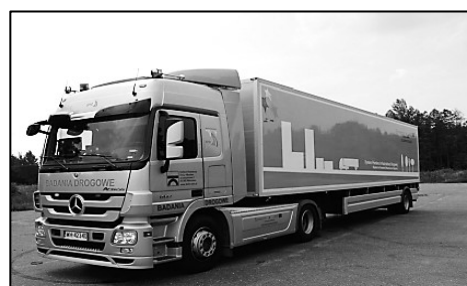
b. Traffic Speed Deflectometer [22]

Emerging NDT pavement inspection technologies also include Traffic Speed Deflectometer (TSD), Infrared Thermography (IRT), Impact Echo, and other portable or vehicle-mounted sensors. Figure 3.8.a shows an example of Seismic Pavement Analyser (SPA) device, a seismic-based tool (based on impact hammers) for in-situ measurement of pavement layer material properties (stiffness) and thickness. Through analysis of the stress wave propagation speed, SPA is capable of detecting sites of material deterioration and the presence of discontinuities, such as voids, cracks, and delaminations. Unlike RDD, TSD (or Rolling Wheel Deflectometer) is a truck mounted system that measures pavement deflection from a large dynamic mechanical load at traffic speed although providing significantly lower resolution results. An example of a TSD system is shown in Figure 3.8.b.

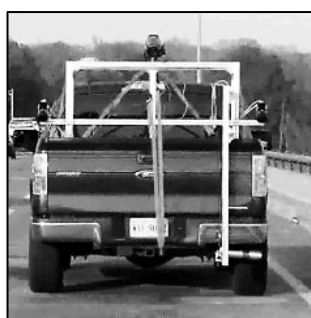
a. NEXCO-West DTSS IR system [31]

sensitivity to environmental and surface conditions. Figures 3.9.a-b show bridge inspection Deck Top Scanning System (DTSS) with IR camera mounted on top of the specially designed vehicle and an example of an integrated GPR and IRT system for bridge deck inspection. Recently, Solla et al. showed successful application of combination of GPR and IRT for cracking detection and its severity evaluation in asphalt pavements [16]. IRT is also used for temperature measurement during HMA laydown to detect possible thermal segregation locations of the HMA course (Figure 3.9.c). The sites of segregation are characterised by lower density and higher susceptibility to ravelling and fatigue cracking.

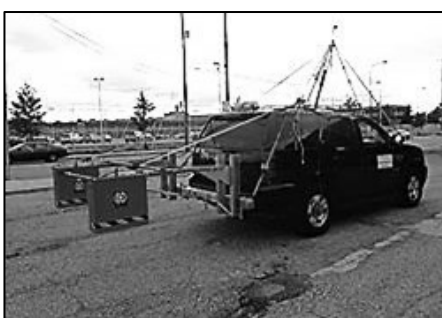
b. Infrasense, Inc. integrated GPR and IRT system [33]

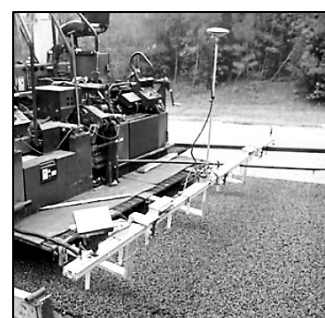
c. IRT measurement of HMA overlay [32]

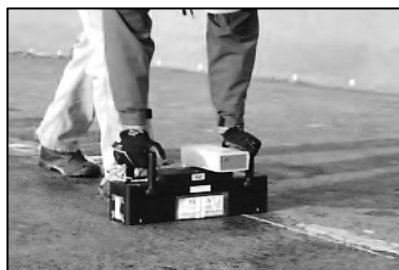
a. MIRA dry-coupled UT pulse echo equipment [36]

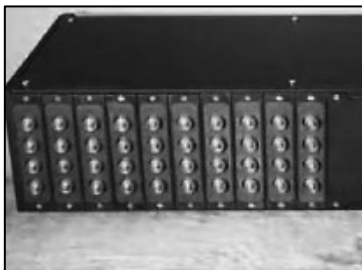
b. MIRA dry-coupled UT transducer array [36]

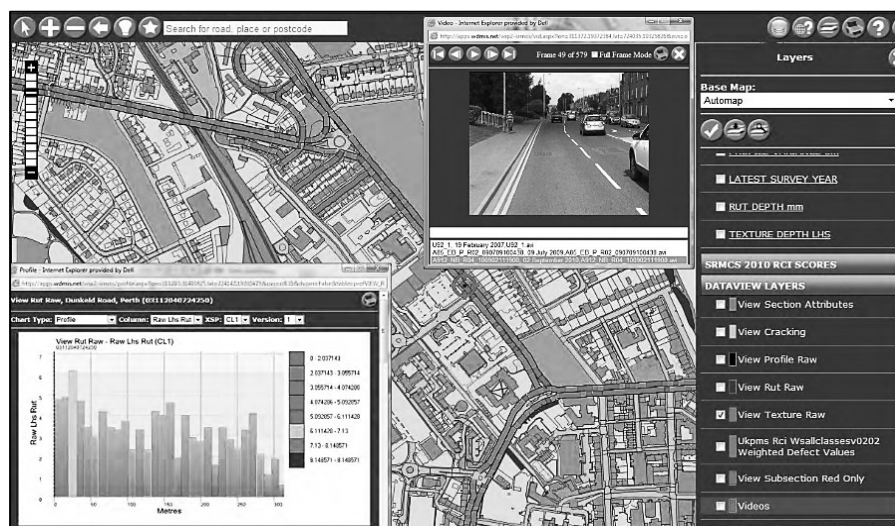
Figure 3.12 Example of pavement management software (WDM® pavement management system) [30]

While maintenance software provides means for planning and control of both routine and targeted maintenance works. The figure below shows an example of pavement management system with visualised measurements of rutting severity along the city map.

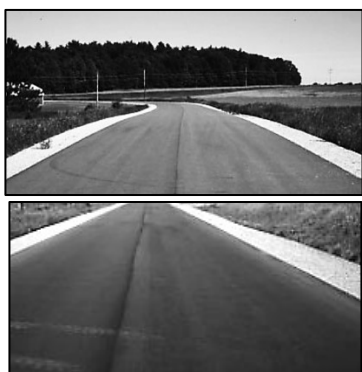
a. Rating 10&9: Excellent / new or recently overlaid roads

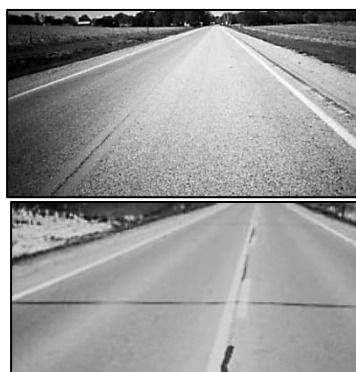
b. Rating 8: Very good / recently sealcoated or overlaid roads

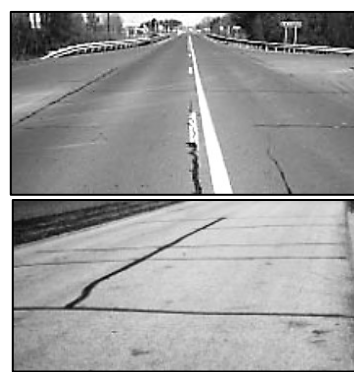
c. Rating 7&6: Good / signs of ageing, sealed cracks of low to medium severity, slight ravelling

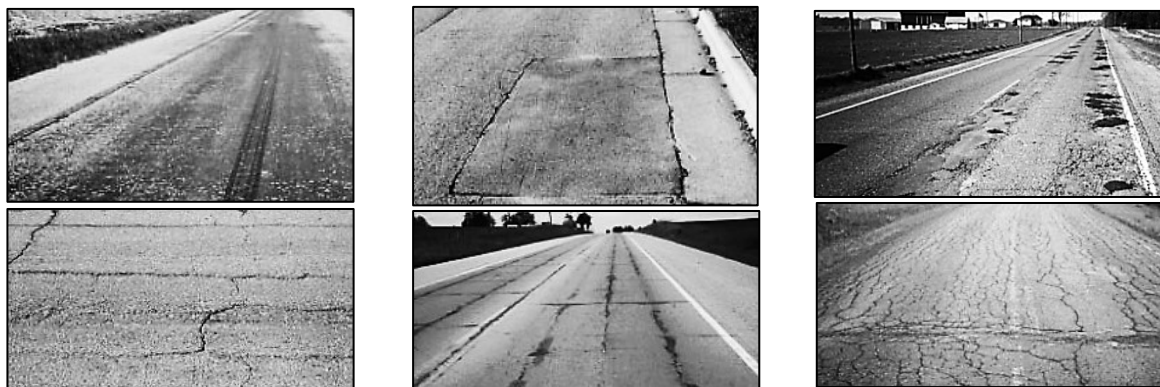
d. Rating 5: Fair / extensive bleeding, medium ravelling, cracking of medium severity (but still in good structural condition)

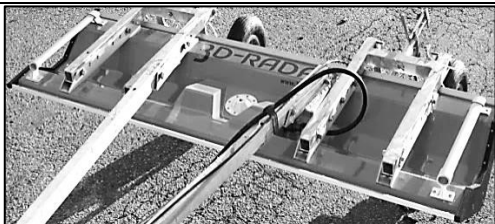
<p>3D-Radar® GPR DX antenna array [21]</p>

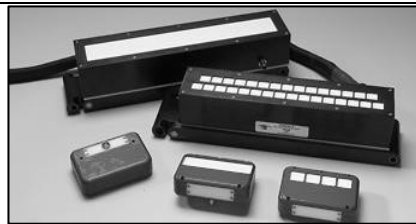
<p>ULTRAN® ACU sensor arrays [20]</p>
Measurements examples

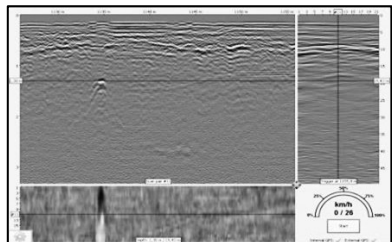
<p>GPR: 3D view of inspected pavement [21]</p>
