Lofty ambitions: Protecting ba

Stacey Waring has spent years counting loops and inspecting underlays that we use in our lofts with great intensity. Stacey has done this because she's recognised roofing membranes can entangle and kill bats roosting in our loft spaces. Ahead of her research being published, she's given us this insight into her work and findings.

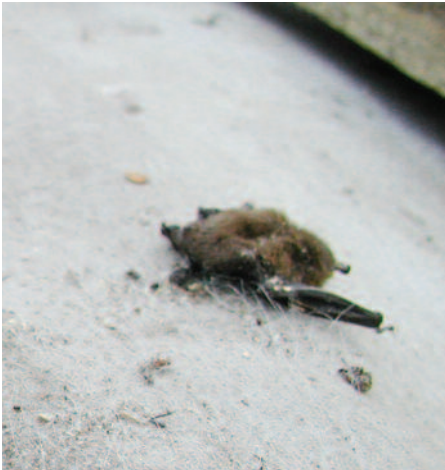
Bats tangled in felt

The first signs of problems came to light following a visit to a Dorset property in 2004, by Colin Morris. The roof had previously been fitted with a BRM and during this visit it was noticed two serotines had become entangled in fluff on the BRMs surface and died in-situ, which was reported to Bat Conservation Trust. At this point BRMs were very new and rarely fitted in properties likely to be

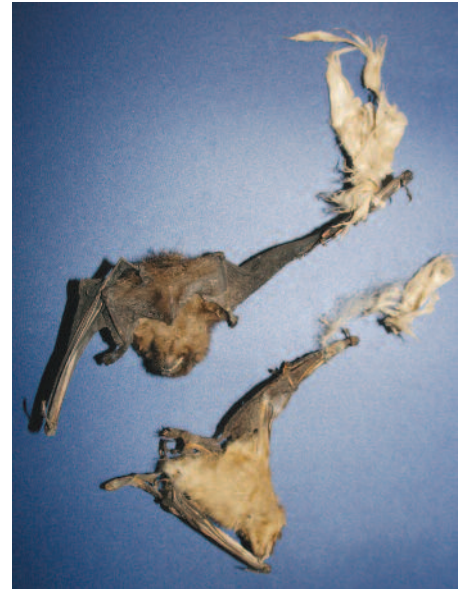
Serotines tangled in BRM

In fact, it is where BRMs have been placed in buildings being used as bat roosts that issues have been raised on numerous occasions. I now have evidence that at least 156 bats have died through entanglement, the majority of which have been pipistrelles and serotines. This number is likely to be much higher as many BRMs fitted in roosts will not be checked for many years and this number only includes bat deaths where we have seen physical evidence and not anecdotal reports. Due to the apparent scale of the problem, it was important that this research project determined what the issues were when BRMs were fitted into bat roosts and whether there were any products on the market that were safe for use where bats were present. A decision was also made to research the effects bats had on BRMs, to ensure that only products that could stand up to use by bats were considered safe. So after preliminary investigations into some of the concerns of bat workers and BRMs manufacturers, three key areas of research were decided upon:

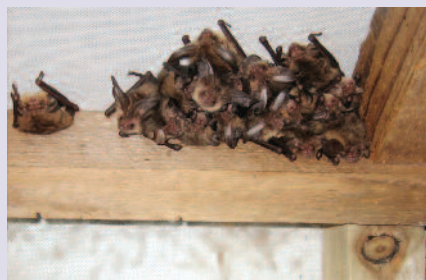
'Greenway is a National Trust bath house situated on the River Dart. Its loft space acts as a maternity roost for lesser horseshoe and brown long-eared bats, around 12 adults of each species. These bats also hibernate in the loft during the milder temperatures of winter along with a single greater horseshoe bat. In 2000 the roof and hanging shingles were replaced and a breathable membrane used. Where the brown long-eared bats have been roosting the fibres in the membrane have pulled loose. I had been aware of a small amount of "fluffing" before I found a juvenile long-eared dead after its thumb had become caught in the resulting fluff.

After several unsuccessful attempts to rectify the situation including placing bitumen felt over areas, using greenhouse shading and other types of roofing membrane etc, I consulted with Stacey, the National Trust and Richard Green Ecology Ltd and it was arranged to have the BRM removed from the ridge beam to the first purlin. Bitumen felt was then fitted between the rafters and is held in place by wooden battens. I am still taking great care to check the remaining BRM regularly as the bats appear to like to use it

for roosting. If any more fluffing occurs then the remaining BRM may also have to be removed. One thing I have observed is that when the BRM starts to deteriorate it progresses extremely quickly."

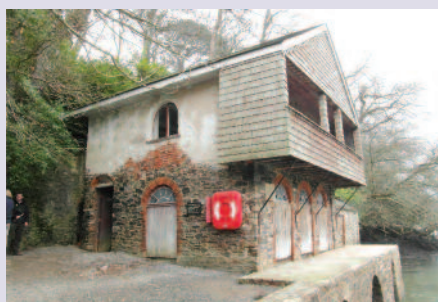
© Richard Green Ecology Ltd - who were contracted to advise on BRM removal at Greenway
